# IRRIGATION SYSTEM FOR AN AGRICULTURE PROJECT ON FARM GAI KAISA NO. 159, OTJOZONDJUPA REGION, NAMIBIA

PROJECT NUMBER: ECC-118-579-REP-02-D

REPORT VERSION: REV 02

DATE: 13 FEBRUARY 2026

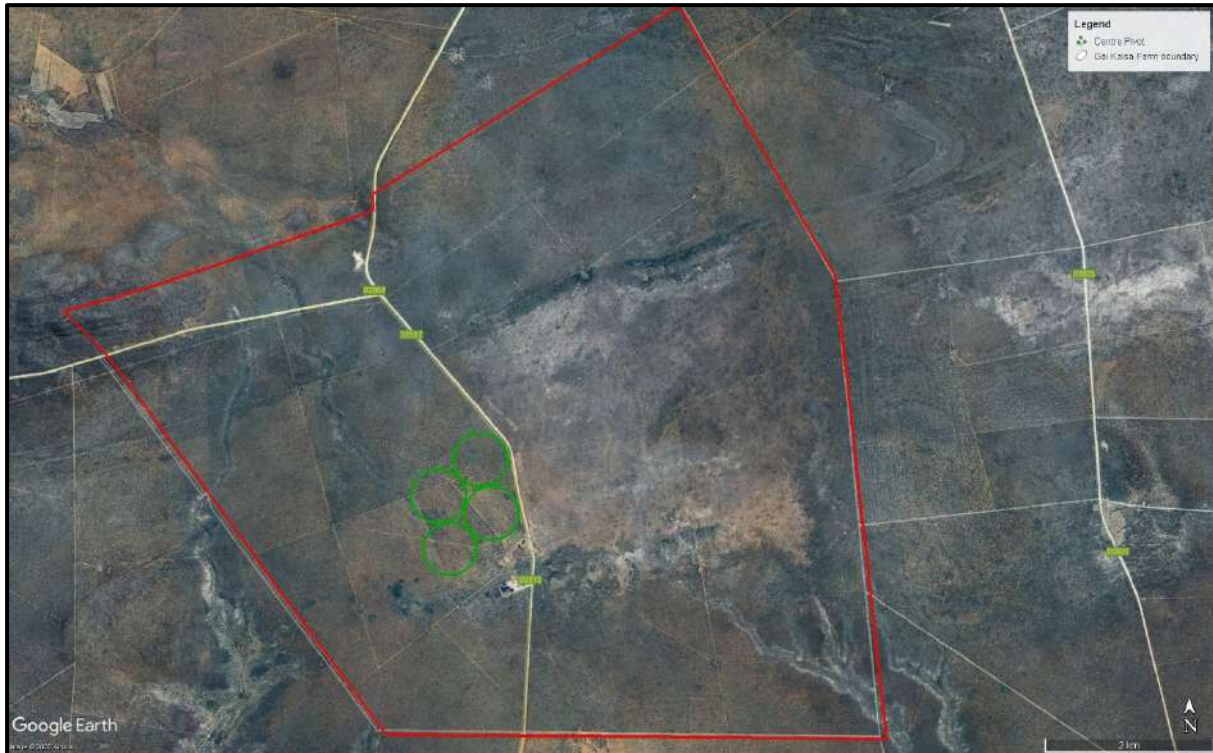
**Figure 11 – Area on Farm Gai Kaisa (red polygon) planned for centre pivot irrigation (green circles)**
