**THE ENVIRONMENTAL MANAGEMENT PLAN (EMP) FOR
THE EXISTING PA LOOTS T/A BRANDBERG SERVICE
STATION IN UIS IN THE ERONGO REGION TO SUPPORT THE
APPLICATION FOR ENVIRONMENTAL CLEARANCE
CERTIFICATE (ECC)**

VERSION: DRAFT

ECC APP NO: 007345

Client: PA Loots T/A Brandberg Service Station

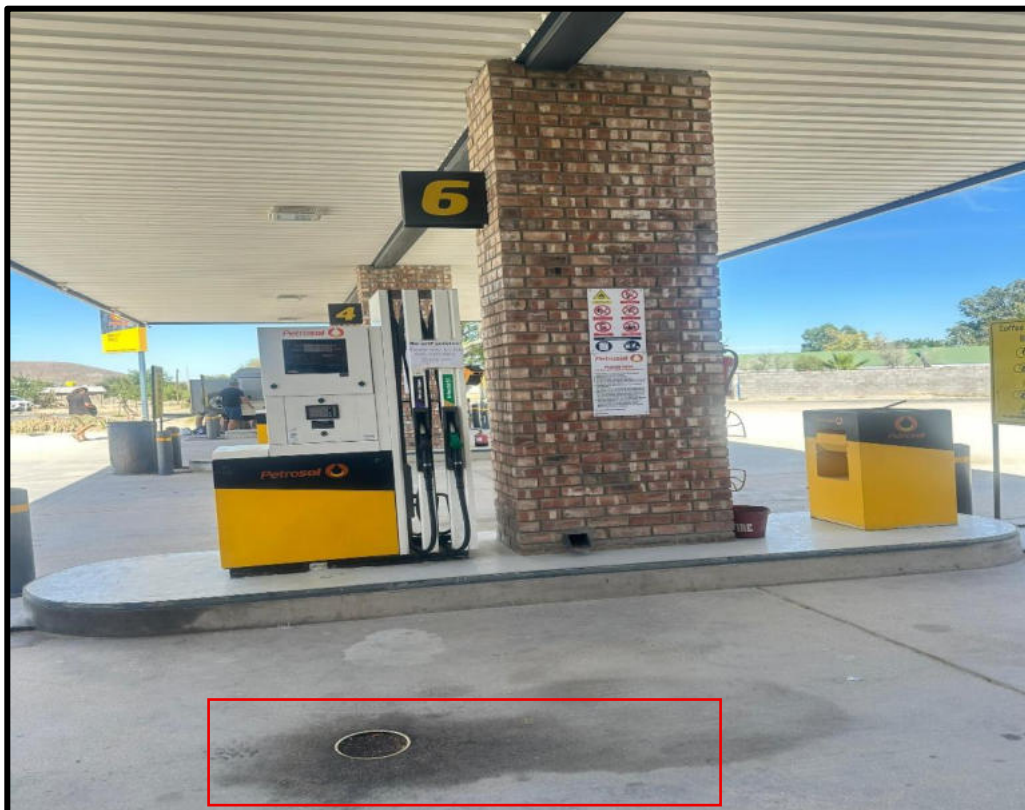
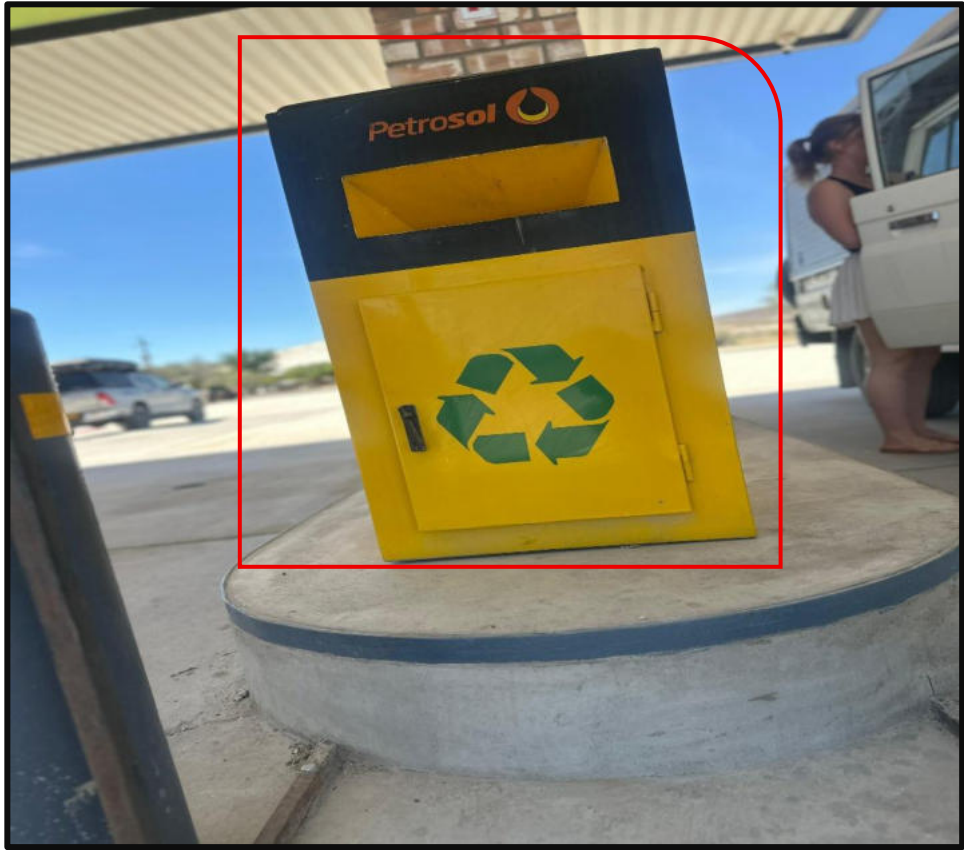
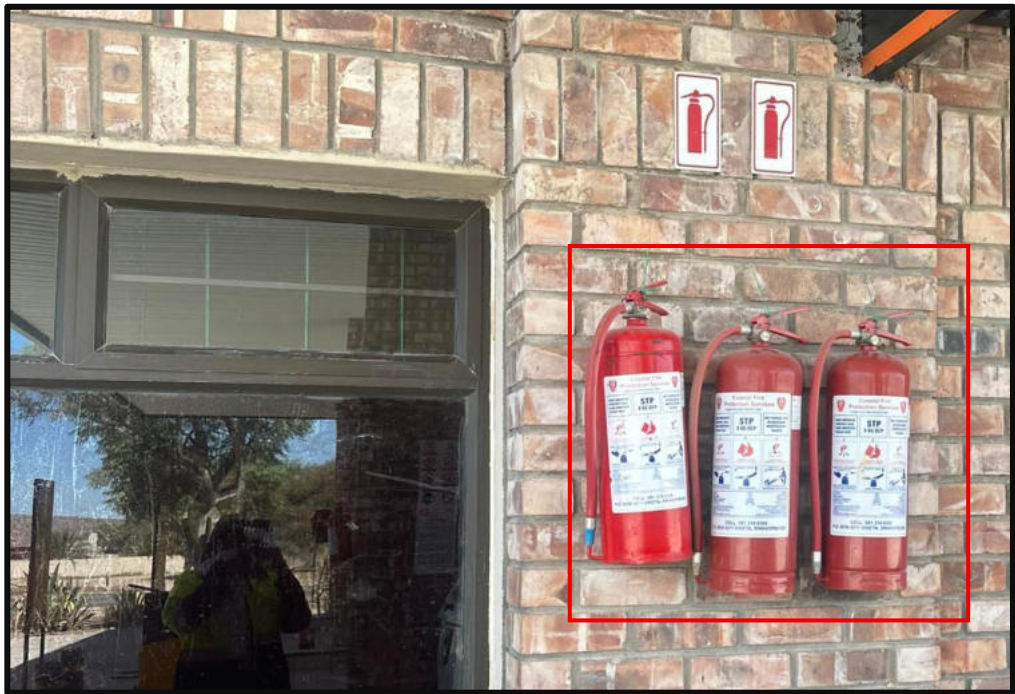
Figure 2 Some of the fuel retail facility areas

The Fuel retail facility comprises buildings that include a mini shop, storeroom, toilets, and offices. The remainder of the facility area contains underground storage tanks, fire extinguishers, fire hydrants for emergency control, product pipelines, and a control room for monitoring and controlling product movement. The offloading areas have drainage pits connected to the separator pit for wastewater collection. The fuel storage capacity consists of three tanks, each holding 23,000 litres.
