## **Flood Control using the Automation Tops Spillway Gates: A case study of the Avis Dam, Namibia**

P.D. TOWNSHEND, Flowgate Projects (Pty) Ltd, RSA  
K.A. LUND, Lund Consulting Engineers, Namibia

**SYNOPSIS.** The Windhoek City Council in Namibia required the maximum discharge from the Avis dam for the 1 in 100 year flood event to be limited to almost half the inflow peak to prevent undue flooding through the city.

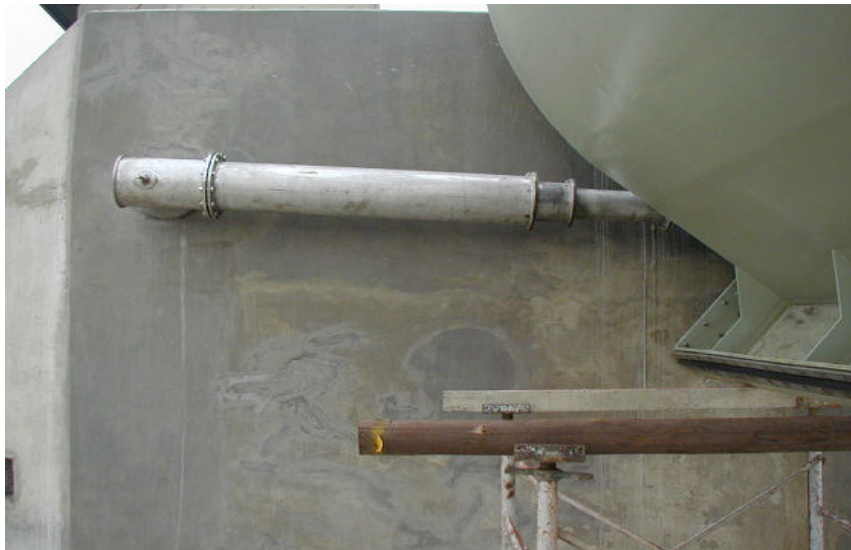
For these particular TOPS gates, a telescopic arm connects the ballast tank to a float controlled discharge valve. When the water level rises above 300mm over the gate, the discharge valve will open automatically to release water from the ballast tank thereby reducing the closing moment which then causes the gate to open.

Telescopic arm connecting the ballast tank to the float controlled valve.

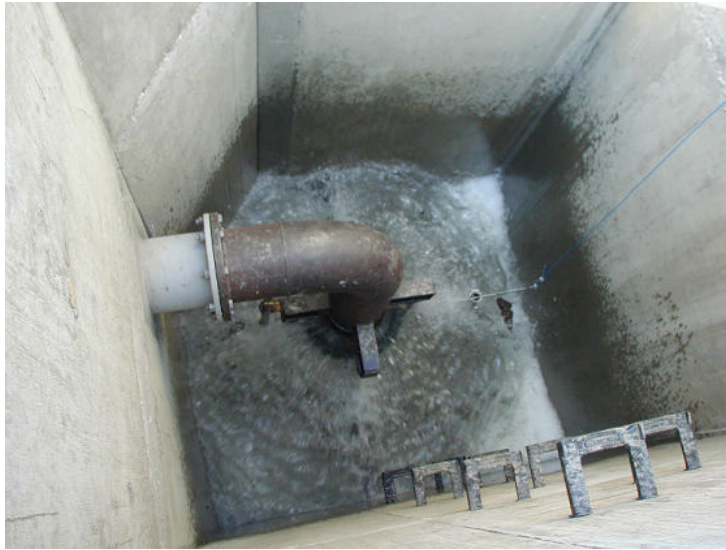
As the water level in the dam drops as a result of the discharge through the gates, the discharge valve closes automatically, water flows into the ballast tank through the 4 openings to the dam to add mass to the ballast tank thereby causing the gate to close.

Float controlled discharge valve discharging water from the ballast tank

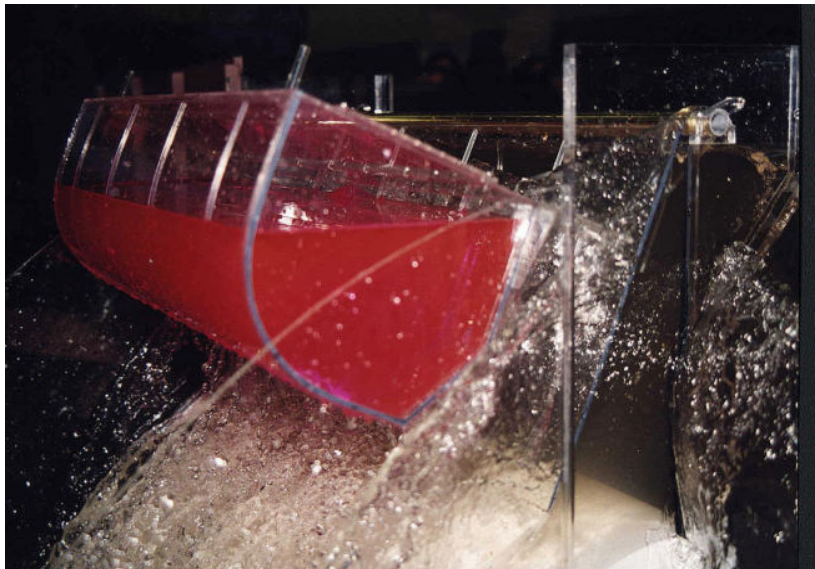
A 1 in 20 scale perspex model was built of the gate and spillway. It was tested in the Stellenbosch University Hydraulics laboratories by independent researchers.

The angular displacement of the gate was measured for different upstream water levels and flows and the discharge characteristics of the prototype determined.

It was determined that the gates would rotate to  $55^\circ$  to the horizontal to pass the required flow.

It was also noted that the gates could open considerably more to pass larger flows but in this case the movement of the gate was stopped at  $55^\circ$  rotation to give the required discharge.

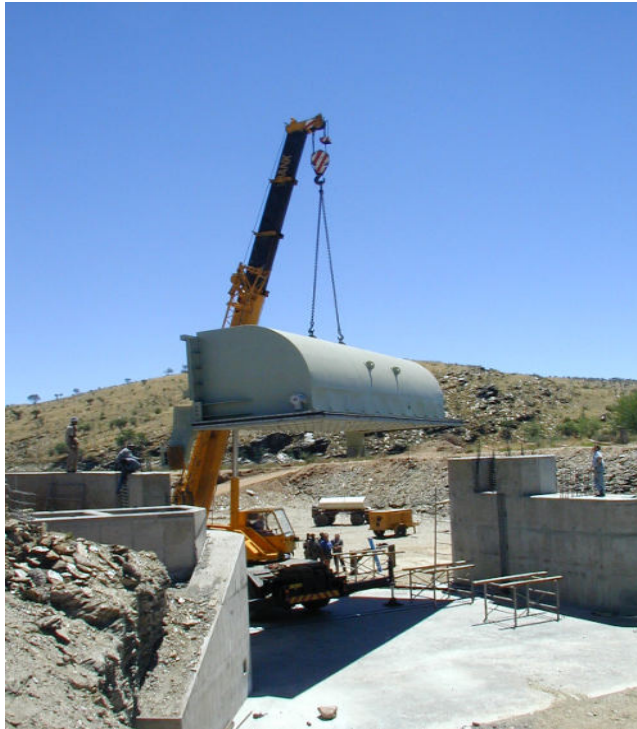
The gates were then lifted into position by a 35 tonne crane and placed over holding down bolts to locate and secure the trunnion brackets.

Gate lifted complete into position

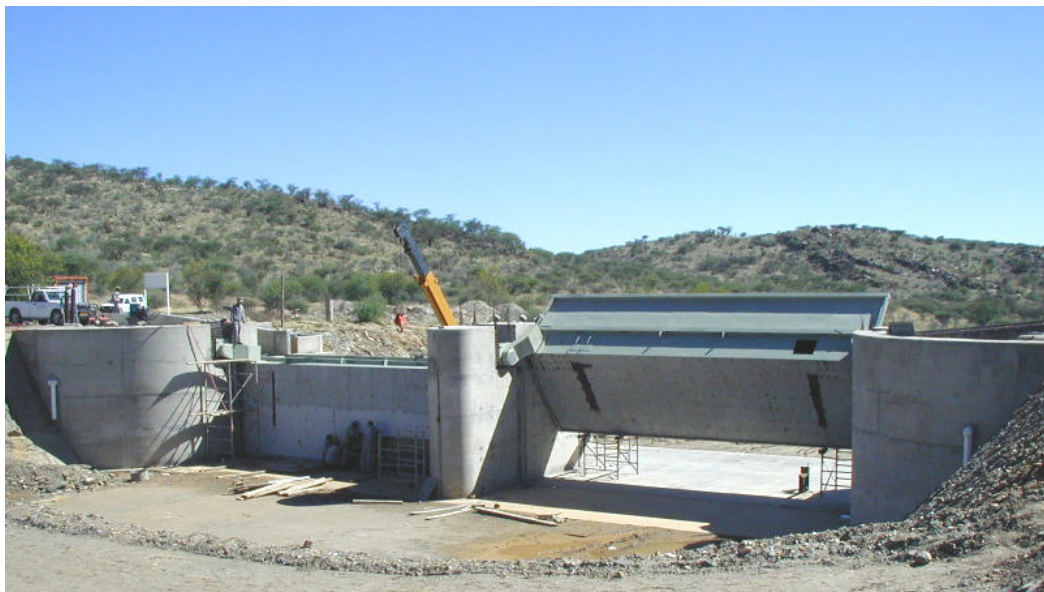
Gates installed ,one partially open

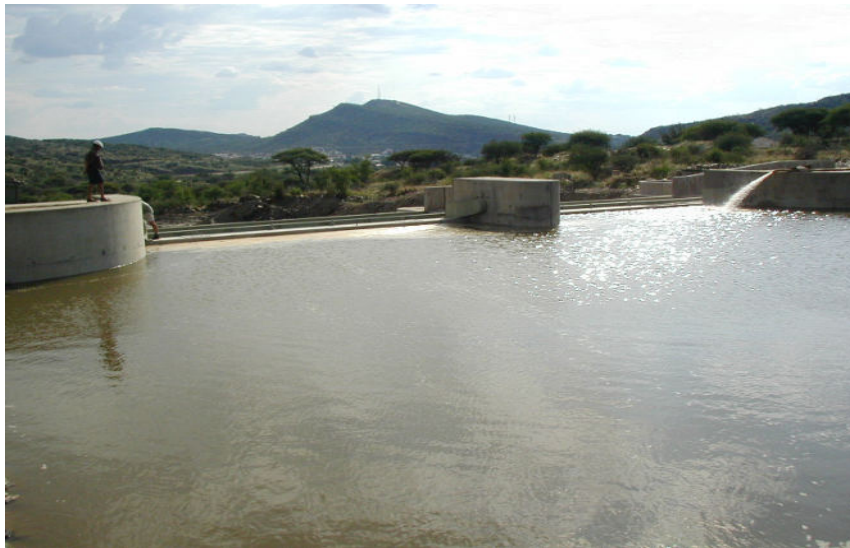
An earth coffer dam was constructed 20m upstream and water then pumped in behind the gates over two days to reach the final depth of 3,5m above sill level. The gates did not show any sign of distress.

Gates retaining full 3,5m water

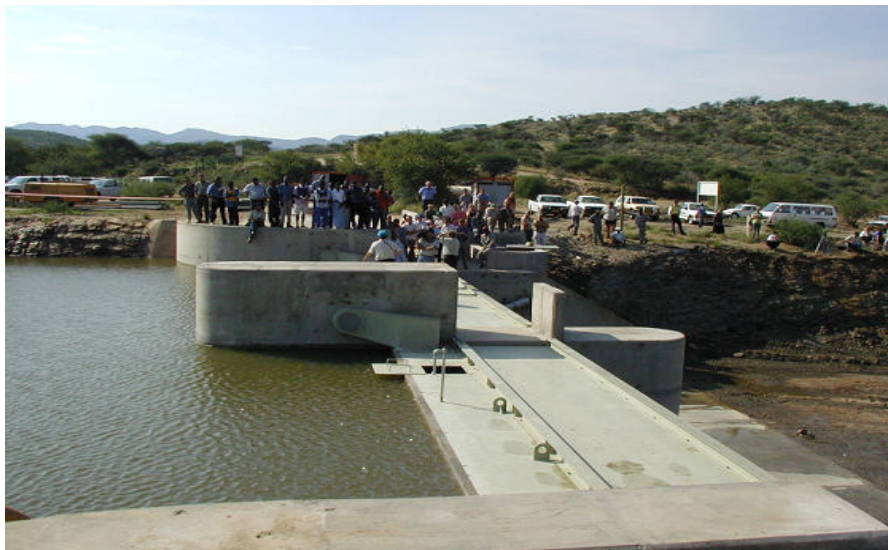
The various components such as the level control discharge valve and the manual butterfly valve were wet tested.

Gates ready for wet commissioning

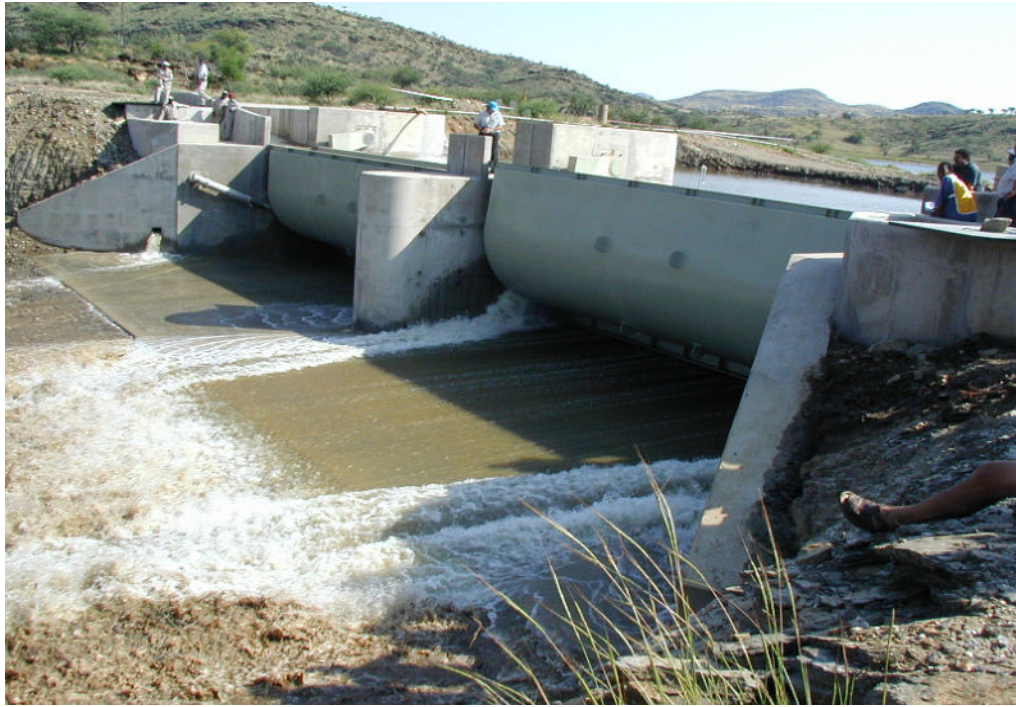
With 60 interested observers and dignitaries in attendance the float controlled valve and manual valves were opened to release water from the ballast tank. At a drop of water level in the order 0,9m in the ballast tank, one gate opened and then the other.

One gate opening

Unfortunately here was insufficient volume of water behind the gates to maintain an almost constant water level which is required to open the gates fully. The first gate opened partially which rapidly drew the water level down behind the gates so that full opening could not be achieved.
