**ENVIRONMENTAL PERFORMANCE REPORT**

**FOR LODESTONE NAMIBIA**

**May 2023**

**Project No: NSP2023LS1**

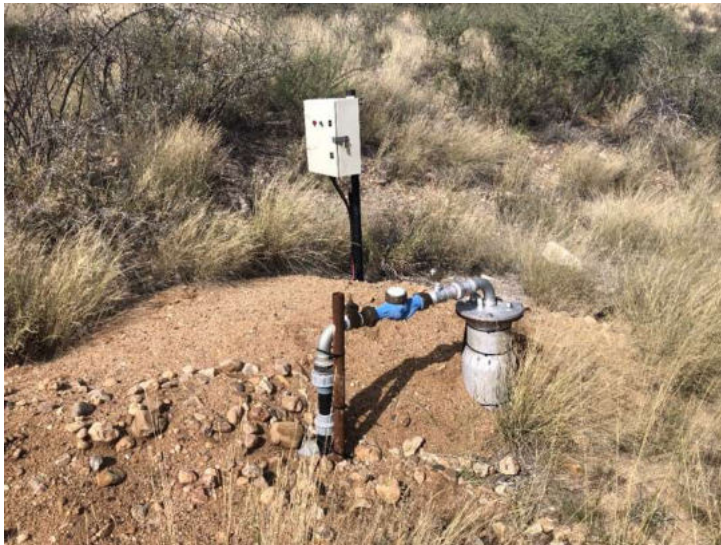
**FIGURE 6: ONE OF THE ABSTRACTION BOREHOLES**

Current (small-scale) supply of water onsite comes from abstraction boreholes. Figure 6 is of such a borehole. The water is pumped to plastic tanks from where the water is distributed onsite (see Figure 7). The amount of water abstraction is monitored monthly for reporting to the Directorate of Water Affairs (DWA), as required by the abstraction permit.

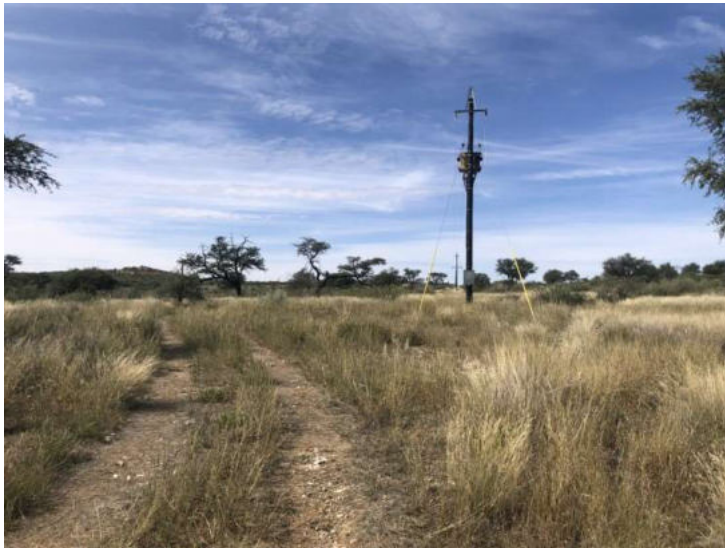
**FIGURE 8: THE POWERLINE THAT PROVIDES ELECTRICITY TO THE ABSTRACTION BOREHOLES**

Nampower provides power to the abstraction boreholes as well as the site via two 11kV overhead powerlines, both coming from the main Seeis line. Figure 8 shows the powerline to the abstraction boreholes and related pumps that provide the water to the tanks onsite.

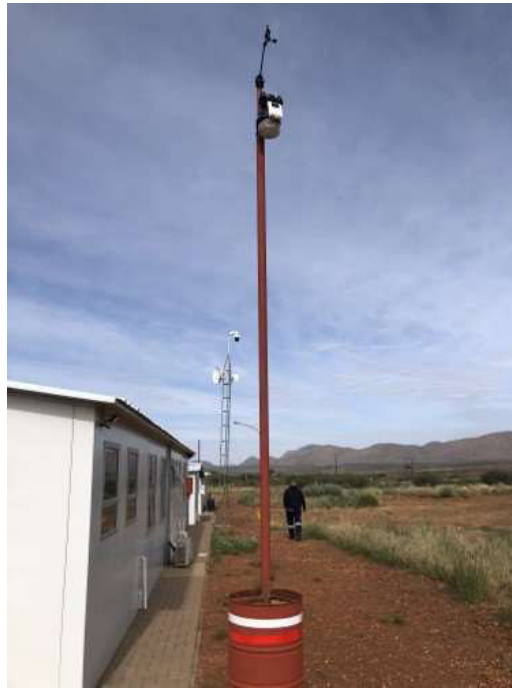
**FIGURE 16: NEW WEATHER STATION ONSITE**

- No dust-a-side is applied, and no water sprays are being done. Dust generated from the mining activities remains a concern, despite the low intensity activities currently.
- No dust monitoring is being done currently.
- No PM10 sampler has been installed, as the EMP requires.
- The weather station (Figure 16) is monitored, and the information is recorded for reporting purposes. However, this information is not applied for the purpose of managing dust.

- It is commendable that the weather station (see Figure 16) is monitored, and that the weather information is recorded, but this information does not mean much without the monitoring of dust. It is thus essential to restart the dust monitoring program – as the weather data will be supplementary to its management and may assist in identifying and describing certain dust trends in space and time.
