ENVIRONMENTAL AUDIT REPORT FOR IMERYS GECKO OKANJANDE GRAPHITE (PTY) LTD

Okanjande graphite mine – Mine Waste Stockpile Area December 2017 to August 2020.

MINING LICENCE (ML)196 & EXCLUSIVE PROSPECTING LICENCE (EPL) 4717

2017- 2020

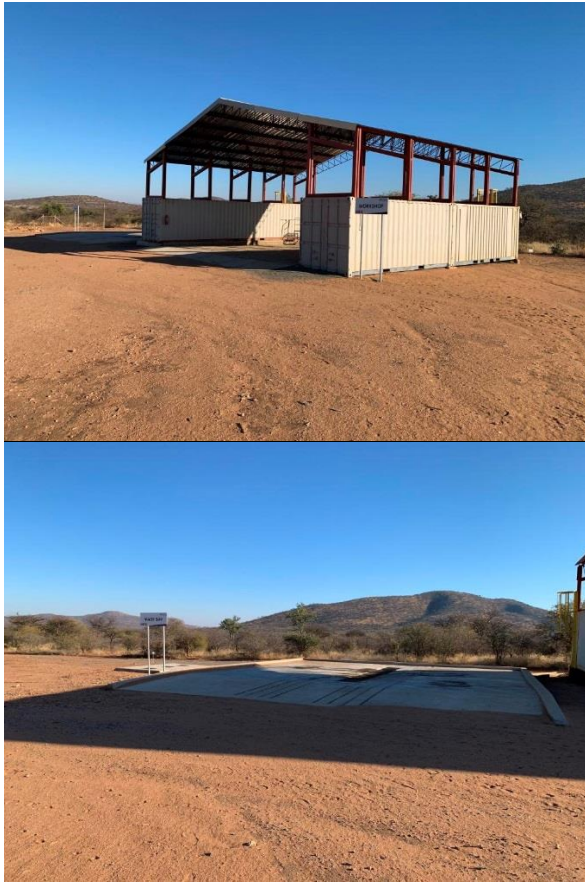
New infrastructure was developed during this last 3 year period. The waste sorting, vehicle workshop, wash bay, offices, parking and generator building were all completed in this 3 year period.

Figure 4 to Figure 6 renders images of these structures. Signage and the general housekeeping is being maintained well.
