## ACCELERATING LANDSCAPE INCISION AND THE DOWNWARD SPIRALLING RAIN USE EFFICIENCY OF NAMIBIAN RANGELANDS

HUGH PRINGLE<sup>1</sup>, IBO ZIMMERMANN<sup>2</sup> and KEN TINLEY<sup>3</sup>

In response to rapidly degrading rangelands there is an urgent need to precondition the land for extremes of weather conditions, which will both mitigate locally against climate change and offer better rain use efficiency and better primary and secondary productivity. Mainstream principles of rangeland management tend to overlook levels of ecological organisation above the “veld type” as well as dehydration caused by landscape incision and the impacts of infrastructure that initiate and accelerate many erosion processes. Dongas erode soil, but far more ecologically significant is their dehydrating impact on affected surrounding landscapes and their sub-catchments. Prior to incision by dongas, the affected landscapes were usually the most productive in their wider catchment context, staying green longer than adjacent run-off and run-through landscape elements and responding rapidly to local rainfalls. Examples are presented from Farm Krumhuk, approximately 20 km south of Windhoek.

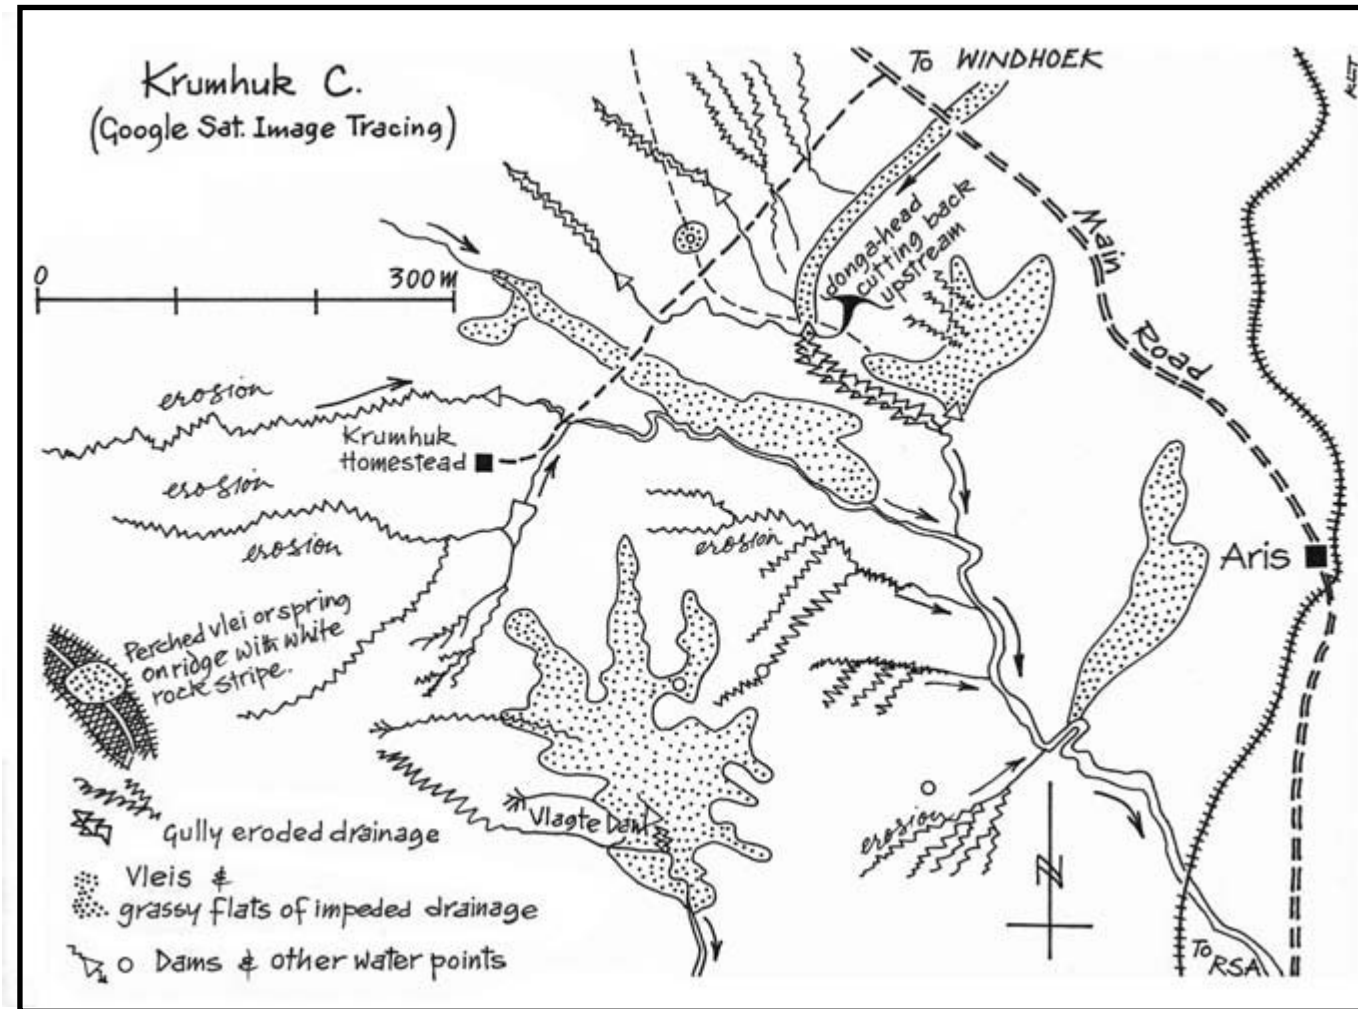
Figure 1. Tracing from Google Earth satellite images of main landscape features in the northern part of Farm Krumhuk, south of Windhoek.

Landscape incision and dehydration, and their initiation by infrastructure, are captured in photographs from Farm Krumhuk, in the Auas-Oanob Conservancy nearby Windhoek. A sketch of the broader study area appears in Figure 1. Satellite images from Google Earth show

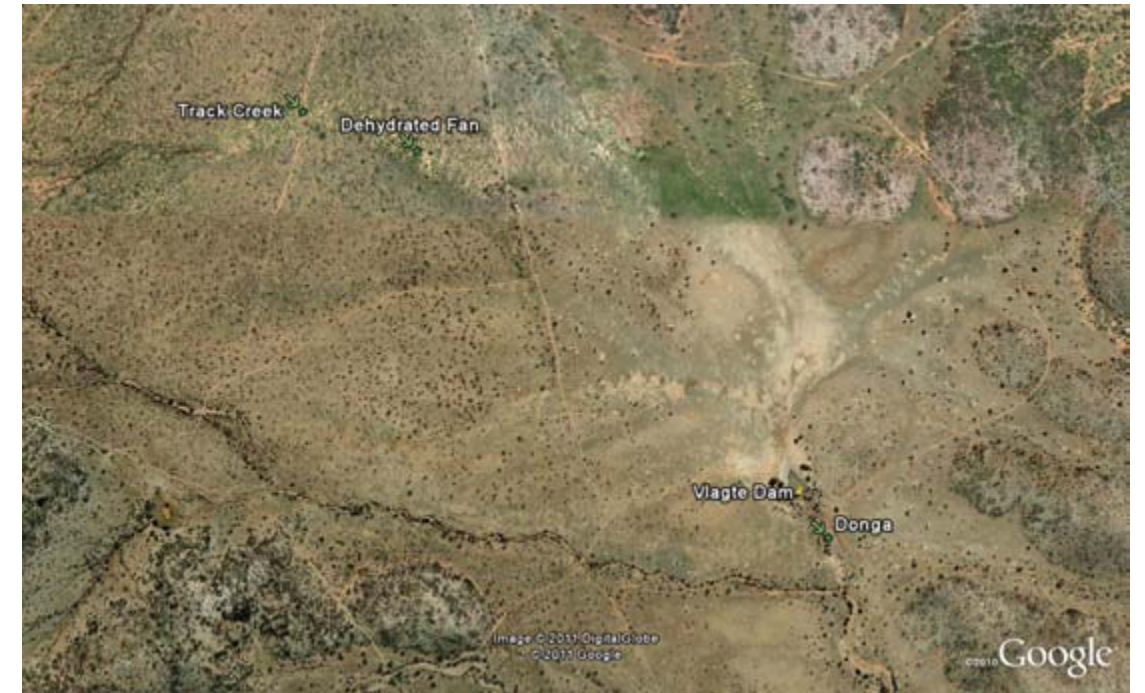
Figure 2. In this example on Farm Krumhuk, a creek flowing out of the mountains (outside and to the left of the Google image) floods out when it meets flat terrain and then splits its sheet flow because of subtle slopes in the plain below. Some goes north-east to a dam near the homestead and some flows down to the vlagte (seasonally inundated wetland) blocked by Vlagte Dam. We know the floodout fan splits because of the distinct donga heads eating back towards the creek's floodout point from different directions. The "track thief" may well have pulled water towards it and an animal path would have been enough to start the donga head upslope (left). Wherever you see sections of track broader than others on Google Earth (which is free), it is likely they are cut down and cutting back laterally (sideways) to drain landscapes. Should either of the donga heads in the case study of the track creek (Figures 9 to 13) reach the floodout point, there will be a downpipe from the mountains to the nearest major channel and that creek's contribution to soil moisture balance of the plain will be totally lost (as has already happened with other creeks).

the broader area where two case studies are located (Figure 2). Figure 3 focuses on the case study area around Vlagte Dam. The coordinates for the dam appear on Google Earth as 22° 46' 03" S, 17° 05' 05" E. Photographs of this case study appear in Figures 4 to 8. The other case study of water capture by a track is illustrated by photographs appearing in Figures 9 to 13.

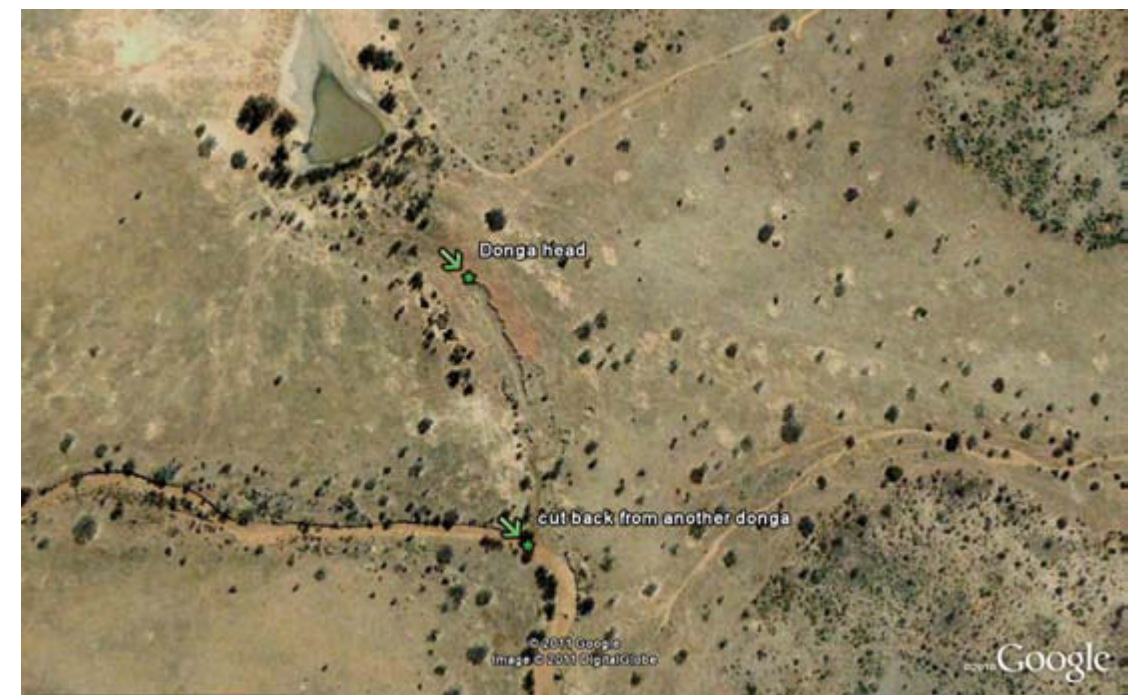
Figure 3. The donga head cutting back towards the Vlagte Dam on Farm Krumhuk has cut back from a more deeply cut down channel that turns sharply west. This deeper channel also ends upslope in gully heads indicating that it is not a natural drainage feature either. The concentrated overflow from Vlagte Dam has spilled over into the incised channel and set off the current donga head cutting back to the dam's spillway. The old, unchanneled water course is parallel to the donga, as indicated by the line of trees.

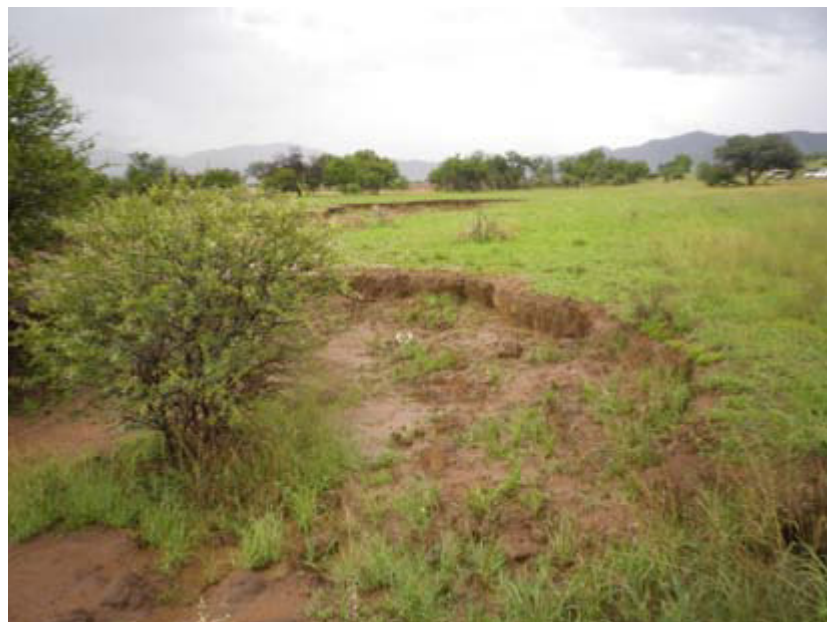
Figure 4. A major donga is cutting up towards the Vlagte Dam overflow alongside a cut off natural watercourse on Farm Krumhuk. The donga is draining a broad seasonally inundated plain. Younger and smaller *Acacia karoo* trees higher in the channel indicate this is a donga, not a natural creek.

Figure 5. A cattle path helps the head of the donga actively pull water towards it. Water flowing over the head's "waterfall" accelerates, thus exerting a sucking force on the water behind. This is how donga heads actively drain landscapes upslope of them. Thus dongas are a major ecological issue, not just a soil conservation problem.

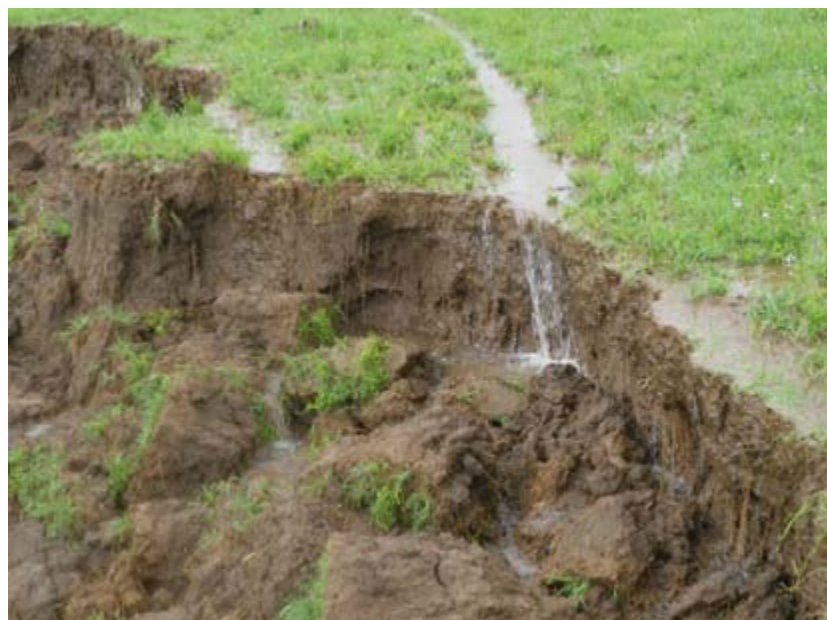
Figure 6. Water actively sucked into the donga quickly finds its way out of the system, thus reducing the landscape's ability to turn rainfall into grass and leading to soils drying out more quickly.

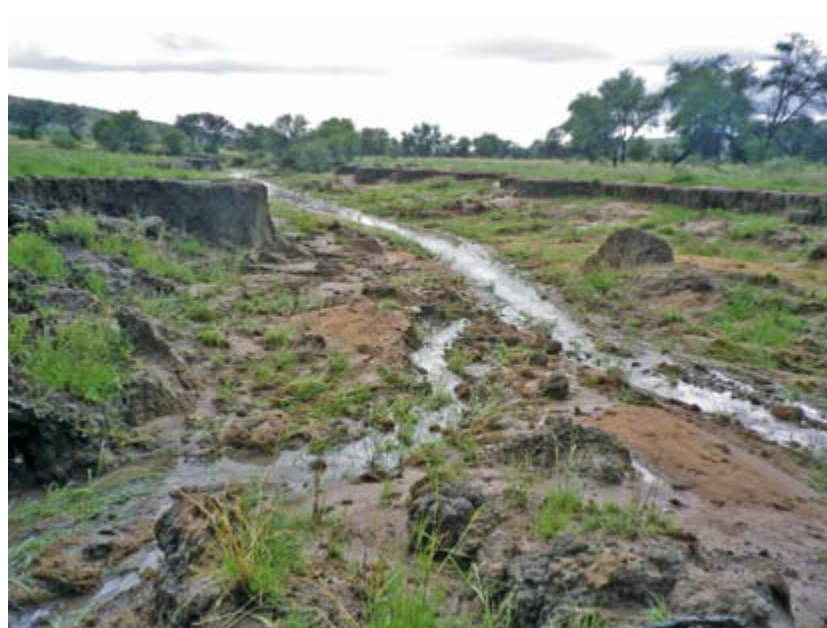
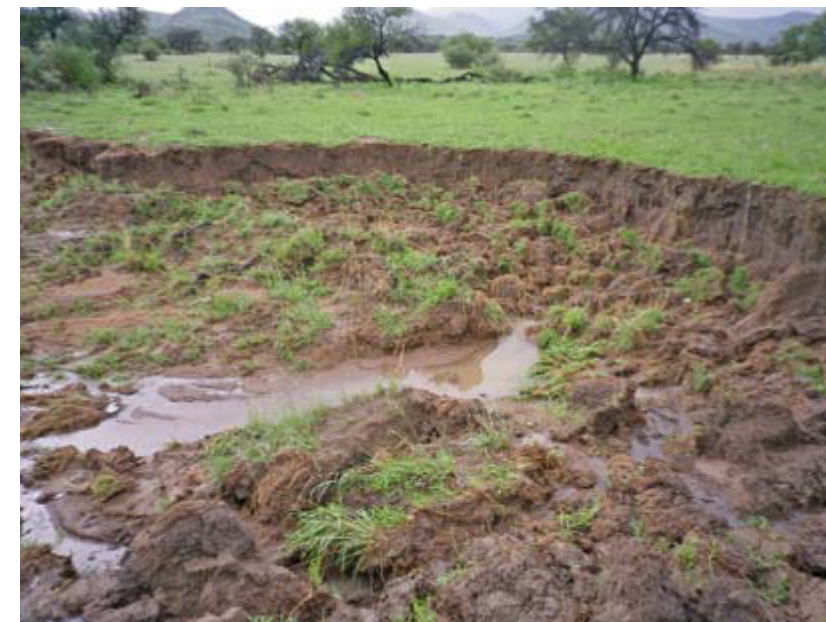
Figure 7. Once the storms were over, it was clear that the donga head had eaten its way back into the healthy ground and well up to five metres in places. Well after the rain stopped, the waterfalls continued sucking the plain dry, with the central, lowest waterfall stopping last, leaving no more surface water upslope.

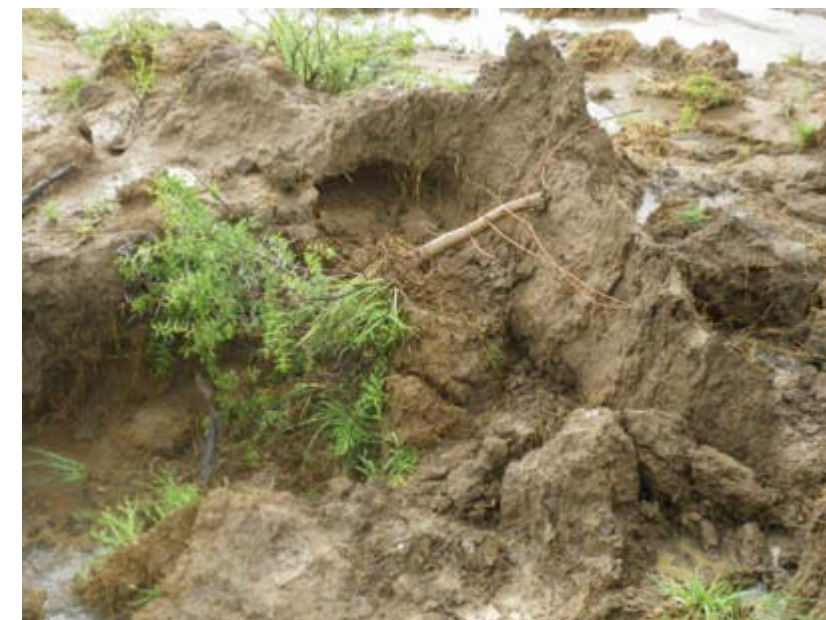
Figure 8. Young *Acacia karoo* plants establish above the rim of the donga head where they are no longer drowned at seedling size. Unlike their counterparts in the most recently formed part of the donga below them, these bushes are doomed, as the donga head will, in the next big storm, erode the soil that now supports them. A larger plant can be seen in the foreground. This plant dates back to an earlier season than the two smaller ones in the background. It may survive until the next major head retreat. Then the two smaller ones will in turn be "hanging on the edge".

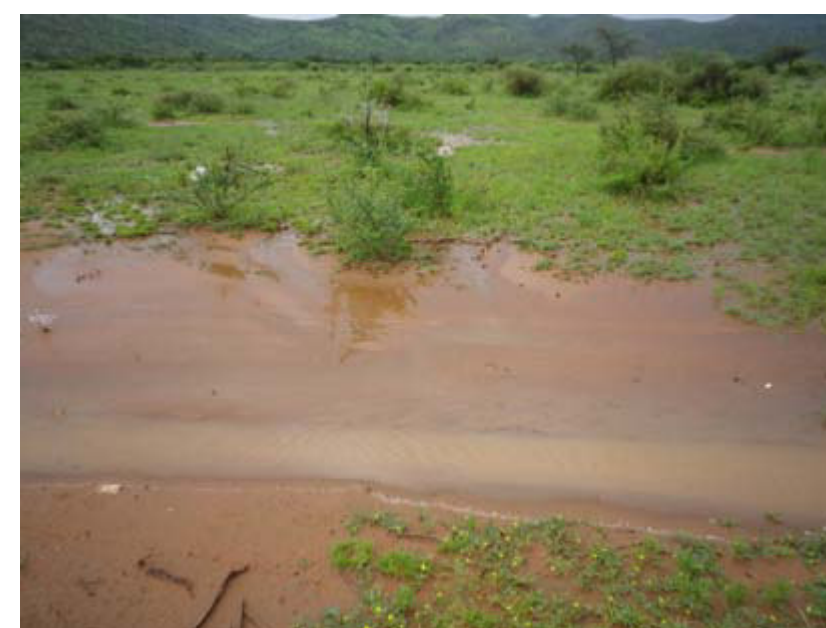
Figure 9. This is an example of how poorly located and constructed access tracks can drain landscapes as effectively as any true donga. In this case a creek from the mountains in the background has flooded out in a fan when it has hit flat ground, depositing rich alluvium in a highly productive system. The track is cut into the land and has started micro-terraces (broad, small water fall heads) cutting back into the floodout fan. The track starves areas of the fan below it.

Figure 10. The waterfall face of these micro-terraces may be less than an inch high, but is very effective in draining areas upslope as the water accelerates over the edge.

With machinery, "track creeks" are also repairable by flattening out windrows to allow natural cross flows. Where the "creeks" have been incised too deep and there is not enough material in windrows to flatten them out effectively, strategically placed small banks can be installed to encourage harvested water to return to its natural course.

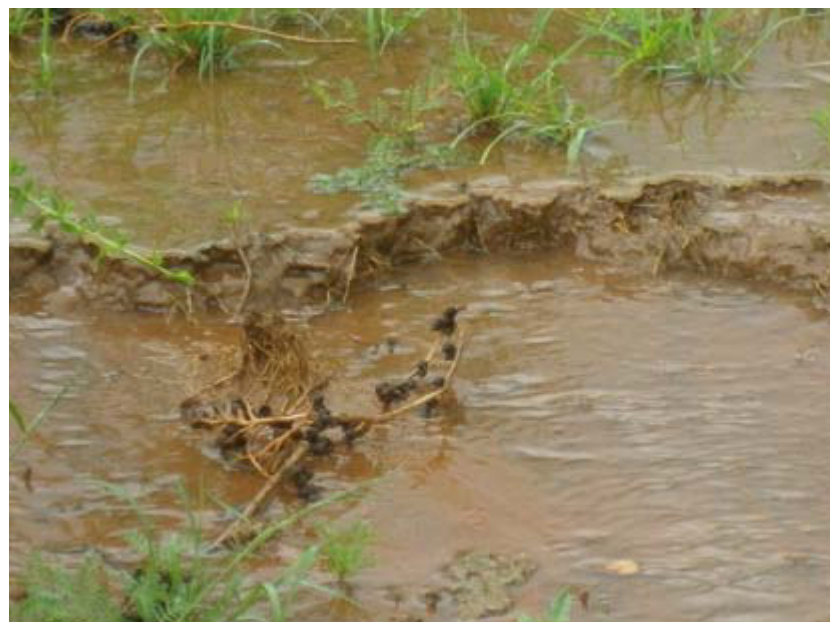
Figure 11. As the micro-terrace faces cut up-slope they often become shallower and get broken up by stable mounds making a pattern of stable islands and stripping rills out of a once water-soaked fan system.

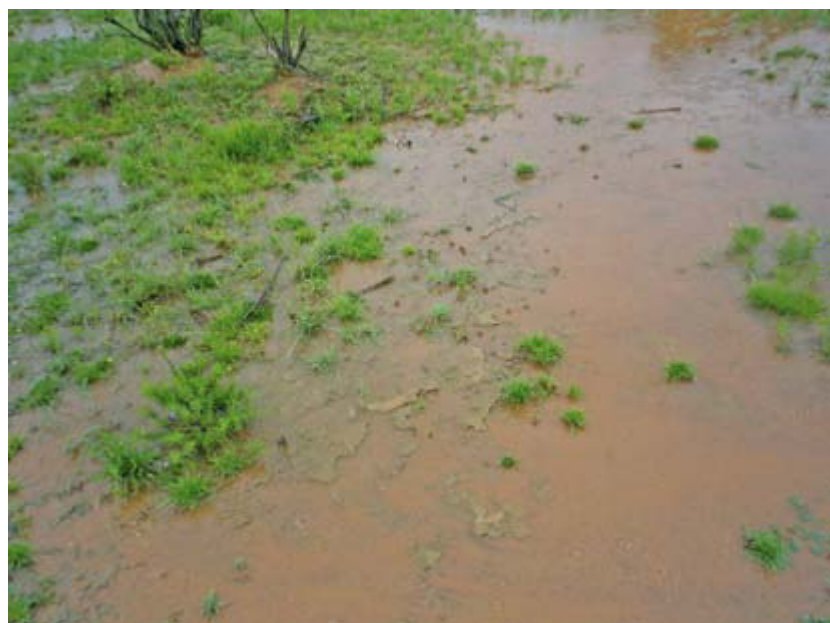
Figure 12. The track is capturing almost all of the sheet flow from the left side and the lower, right hand side of the photograph is now effectively dehydrated by the "track creek".

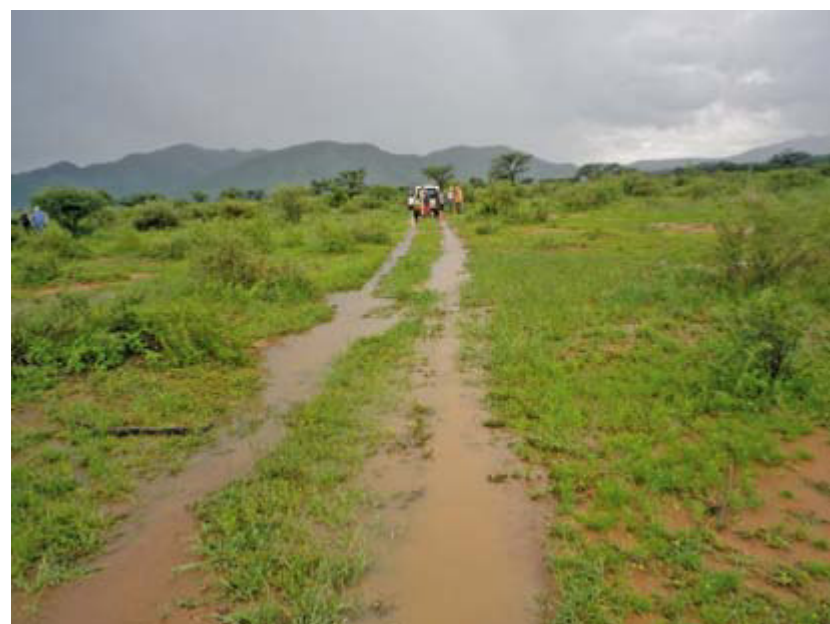
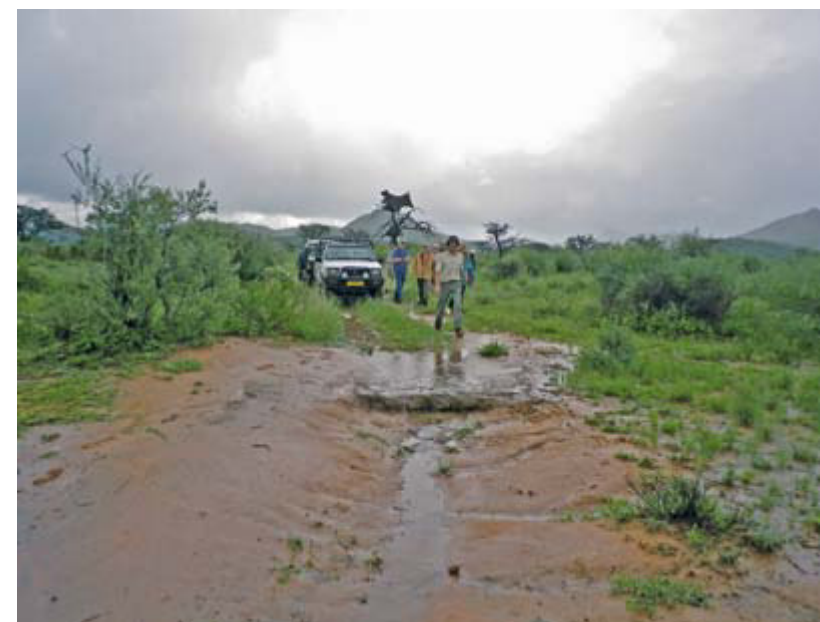
Figure 13. A head is cutting back up the track towards the area of the previous photographs. This head is creating a new, deeper base level below the natural landscape and thus helping the existing track "sucking" the landscape above dry and when it gets back to the area above, it will probably set off a new series of micro-terrace faces to accelerate the drying of this fan and virtually cut off flow to the area of the fan downslope.
